Office of Marine and Aviation Operations

SAFETY NEWS

SEVENTEENTH EDITION

MARCH 2014

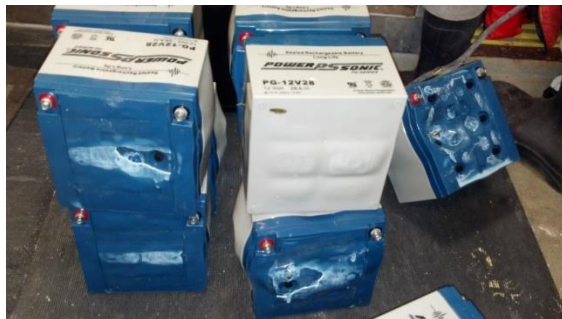
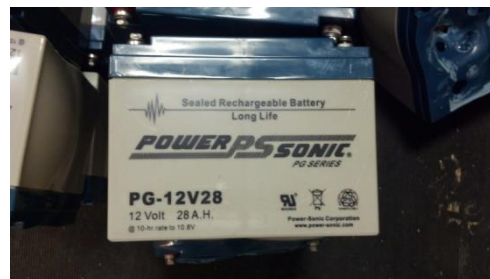
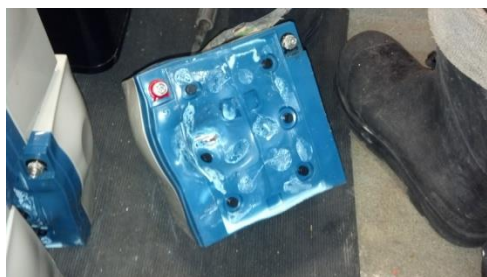
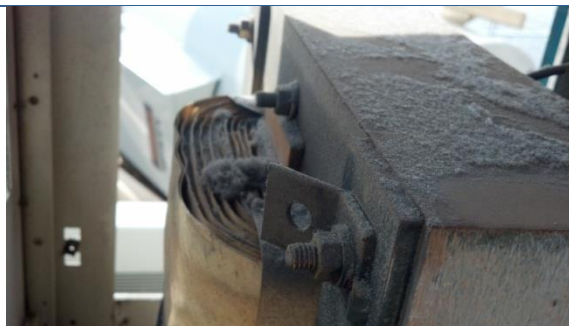
Uninterruptible Power Supply (UPS) Safety Issues – A near miss incident recently occurred aboard a NOAA ship involving failure of UPS battery packs which could have lead to a fire. Upon investigation, it appears the batteries failed on account of significant heat build-up, or the failure resulted in a build-up of heat, either of which could have caused a fire. The battery pack casings were bulged, distorted and breached. A build-up of dust was also discovered on the UPS air vents which may have contributed to heat build-up and failure of the batteries. Those responsible for UPS maintenance are advised to establish protocols for regular maintenance and cleaning of the UPS unit itself, along with inspection of the batteries and associated electrical connections.
